Reliatech Property Inspections
PO Box 19031
Baltimore, MD 21284
410-591-8376

Home Inspection Report

123 Main Sreet
Baltimore, MD 21204

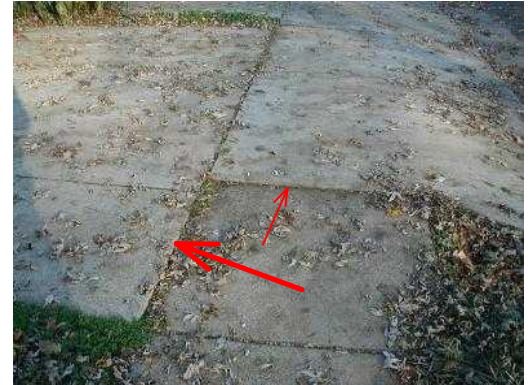
1. Driveway: Concrete
 2. Walks: Concrete sidewalks. Trip hazards noted at several locations on front sidewalk

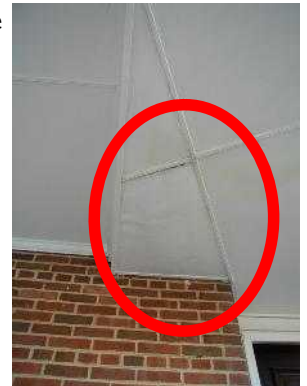
3. Steps/Stoops:
 4. Front porch Concrete slab on grade on right front of house. Some water damage was observed on the ceiling - this MAY be from the bathroom exhaust fan, but I was unable to confirm because there was no access to the space above this ceiling.

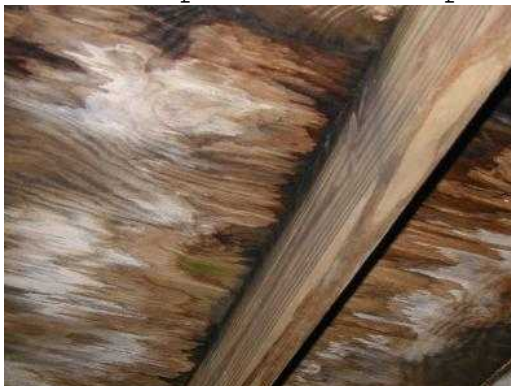
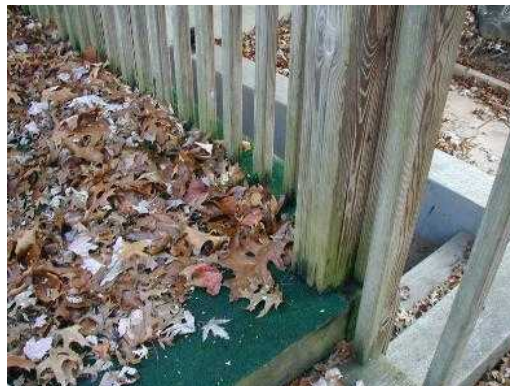
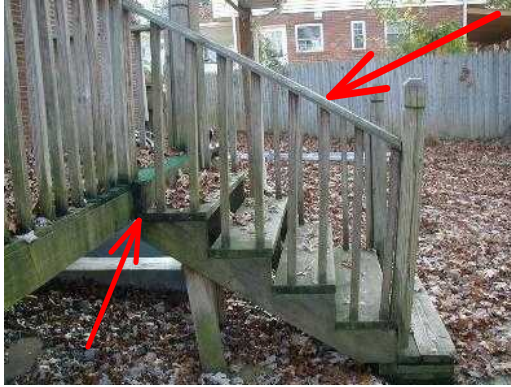
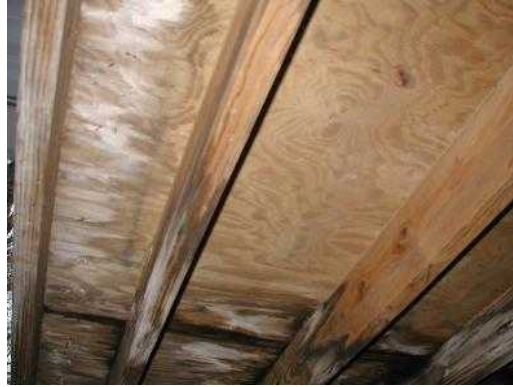
5. Patio:
 6. Deck: Plywood over wood joist. The handrail are very loose. The carpet over the plywood decking holds water and promotes rotting of structure. Plywood should not be used on an exterior deck. The construction indicates poor workmanship.

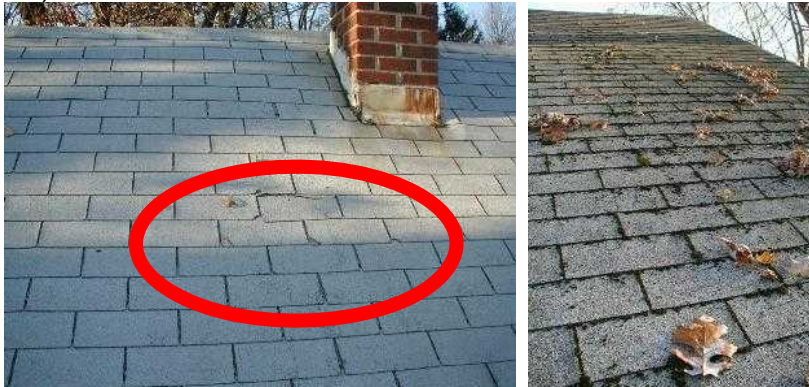
- 1. Method of Inspection: On roof
- 2. Unable to Inspect: 25%
- 3. Material: Asphalt shingle. Loose or damaged shingles were observed. Moss was present on north side of the roof. A qualified roofing contractor is recommended to evaluate and estimate repairs.

5. Approximate Age: Near the end of its useful life, some cracking shingles observed, Some broken shingles observed, Moss growing on the north side of the roof

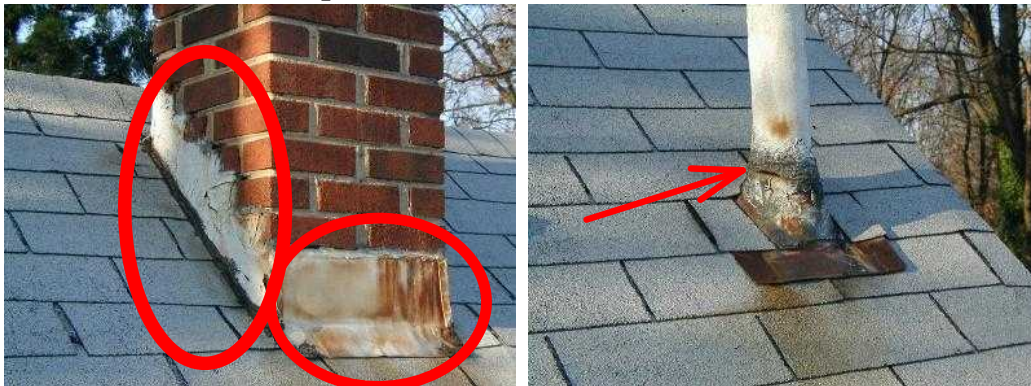
6. Flashing: Galvanized. The flashing at the chimney should be recessed into the mortar joint. The flashing around the plumbing vents is defective and needs to be repaired

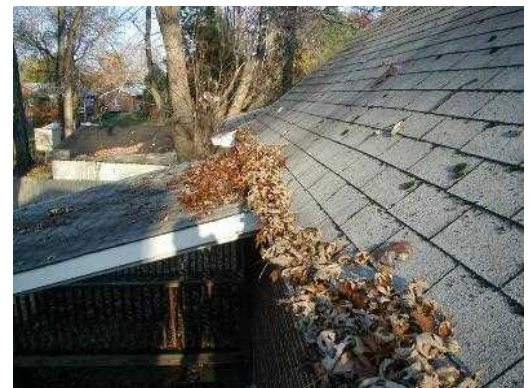
11. Gutters: Aluminum. Although there are gutter guards present, the gutters still need cleaning.

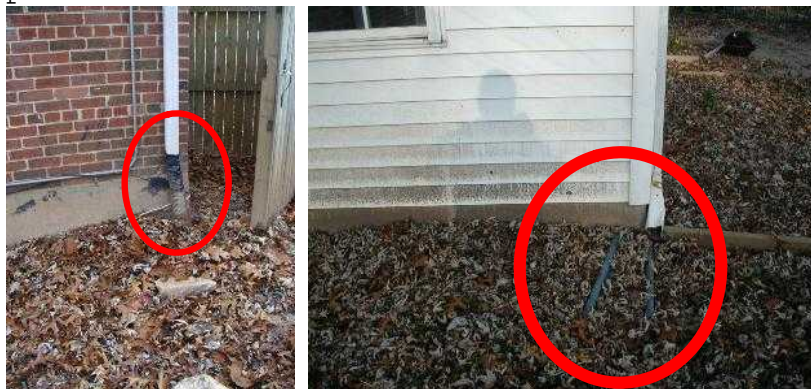
13. Leader/Extension: Some downspouts terminated into ground. Unable to determine where rain water discharges Splash block(s) not properly installed. Leaders do not extend 6 feet beyond the foundation perimeter.

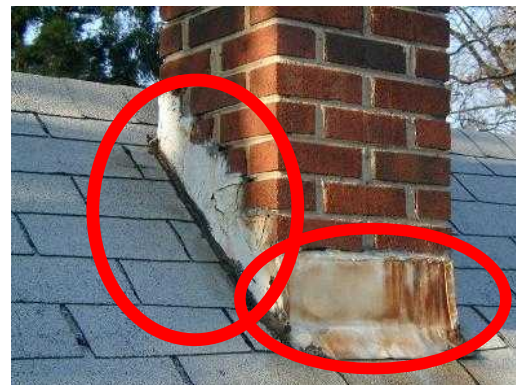
Center Chimney

14. Chimney: Brick construction.
15. Flue/Flue Cap: There is no cap on the flue
16. Chimney Flashing: Metal. Loose counter flashing needs to be repaired.

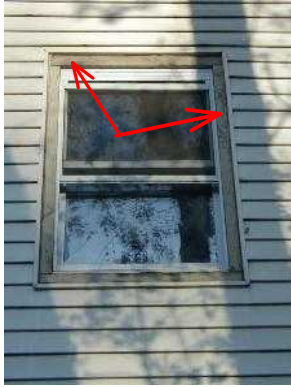
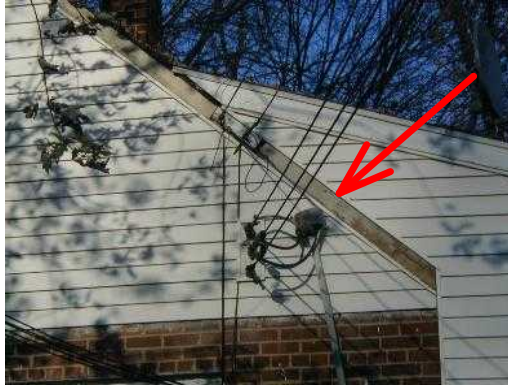
1. Type: The original house is brick construction. The addition is wood framed with vinyl siding.
2. Trim: Some exposed wood trim and some trim wrapped with aluminum Some exposed wood trim is in need of painting or replacement.

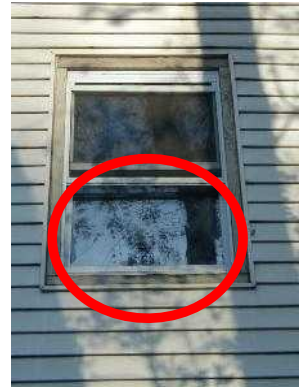
Fascia:
Soffits:
Door Bell:
Front Entry Doors: Wood
Rear Entry Doors: Wood
Patio Door: Metal sliding door. Door hardware was loose
Windows: Vinyl, double hung windows. Several panes of glass were broken, some screens were torn and some screens were missing.

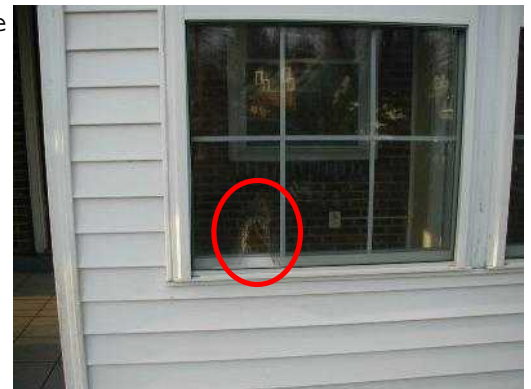
Basement Windows: Steel hopper(hinged at the bottom)windows.
Storm Windows:
Window Screens: Vinyl mesh. Some screens were torn and will need repair

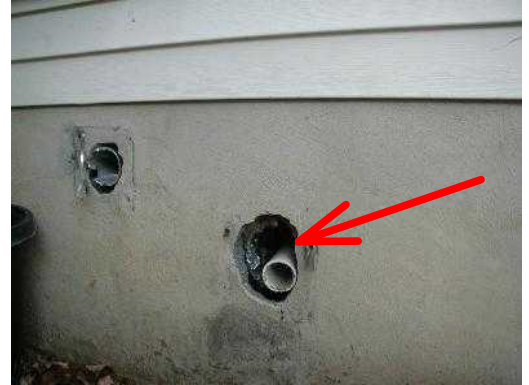
13. **Ductwork:** There is evidence that the dryer exhaust, which is flex duct, runs through the crawlspace. Although I could not observe the duct in the crawlspace because of limited access, I do not believe it can be properly cleaned of lint. This is a fire hazard.

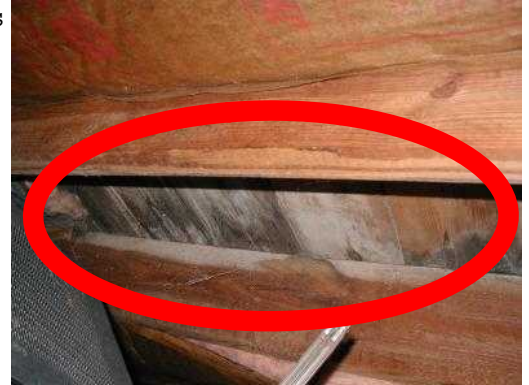
4. **Sheathing:** Dimensional wood The limited areas where the batt insulation between the roof rafters was missing showed signs of water damage.

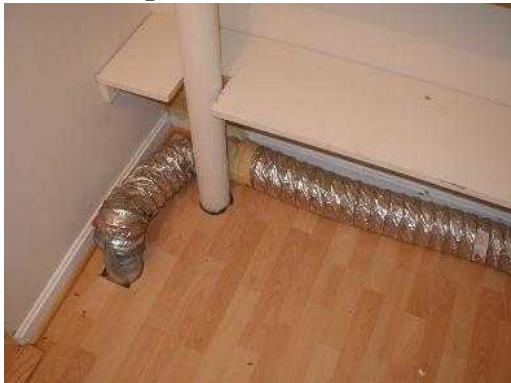
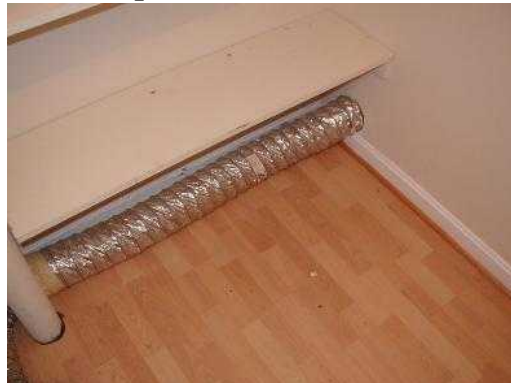
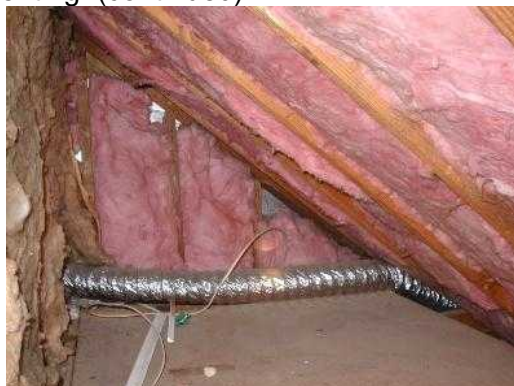
13. **Bathroom Fan Venting:** Unable to determine where the exhaust duct terminates. It is possibly the cause of the water damage to the ceiling of the outside porch noted earlier in the report

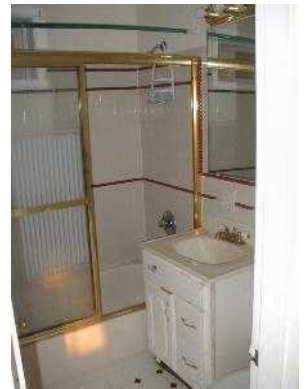
- 14. Floor: Ceramic tile
- 15. Doors: Hollow wood
- 16. Electrical: 110 VAC lighting circuit only. No outlets were found in bathroom.
- 17. Counter/Cabinet: Laminate and wood
- 18. Sink/Basin: Synthetic
- 19. Tub/Surround: Porcelain tub and ceramic tile surround
- 20. Toilets: Appeared to be servicable
- 21. Ventilation: Exhaust fan. Could not find discharge point of exhaust fan. See other comments in report.

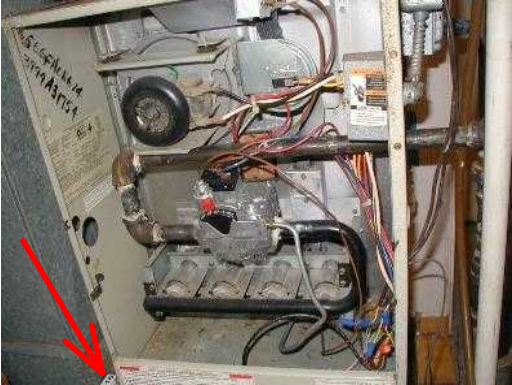
6. Fuel Type: Natural gas
 7. Heat Exchanger: 4 Burner
 8. Unable to Inspect: 90%
 9. Blower Fan/Filter: Filter was filthy and the filter section cover was not in place. The absence of the filter section cover will allow dirty air to by-pass the filter.

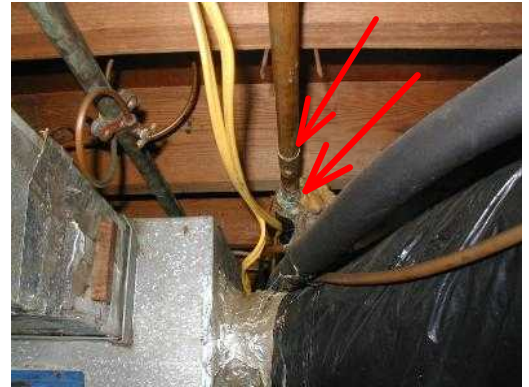
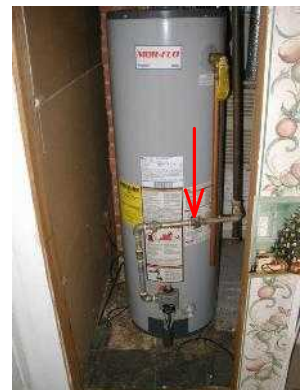
1. Service Line: Copper
2. Main Water Shutoff: Basement
3. Water Lines: Copper. Signs of corrosion and several inline couplings were present. These may be signs of past plumbing leaks. Recommend that all piping be inspected by a licensed plumber. Access to view the pipes was limited by the existing drop ceiling and drywall ceiling in the basement.
4. Drain Pipes: PVC, Cast iron
5. Service Caps:
6. Vent Pipes: Galvanized
7. Gas Service Lines: Black metal pipe. Shut off valve on gas line is broken.

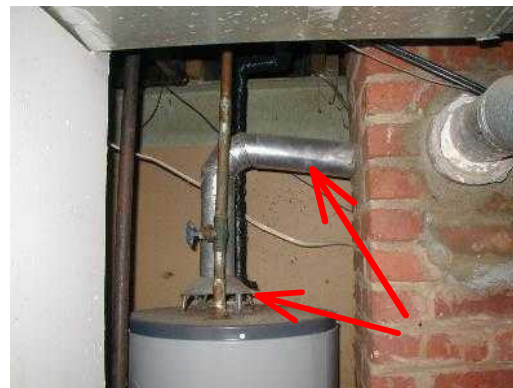
8. Water Heater Operation: Inadequate Flue cap was not properly secured. The flue pipe had a negative slope. The gas shut off valve was broken and because it is a safety hazard, it needs to be replaced by a licensed

- 9. Manufacturer: Mor-flo
- 10. Model Number: MM-50 Serial Number: MM-3456789
- 11. Type: Natural gas Capacity: 50 Gal.
- 12. Approximate Age: 5 years old Area Served: Whole building
- 13. Flue Pipe: Single wall Negative slope

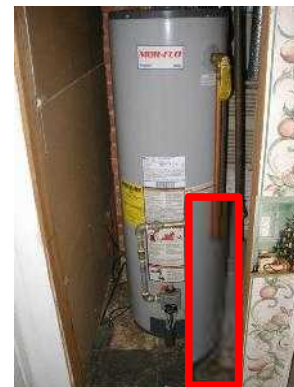
- 14. TPRV and Drain Tube: Copper Drain pipe from TPR valve is greater than 24" off floor. It is recommended that the discharge point be 6" to 24" from the floor.

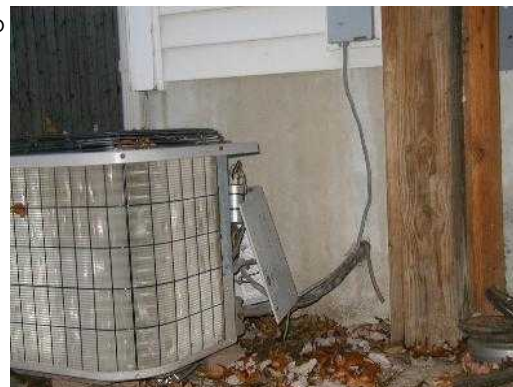
- 1. A/C System Operation: Unable to get the unit to operate, Unit appears to be beyond its useful life. Recommend replacement.

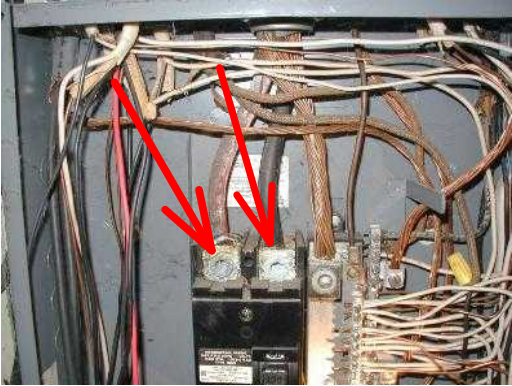
1. Service Size Amps: 150 Volts: 110-240 VAC
2. Service Copper. Evaluation by a licensed electrician is recommended, 14 gauge wires going into a 20 amp breaker (20 amp circuits require 12 gauge wiring). Corrosion evident on incoming feed taps. Rust in the bottom of the panel.
-

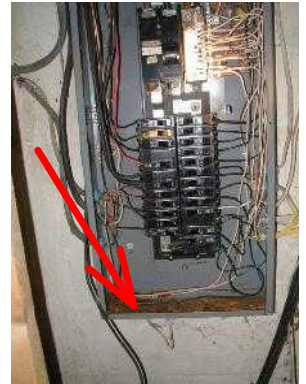
Basement on west side of house Electric Panel

8. Manufacturer: Square D. Evaluation by a licensed electrician is recommended, Panel is rusted inside, Wiring appears to be less than professional

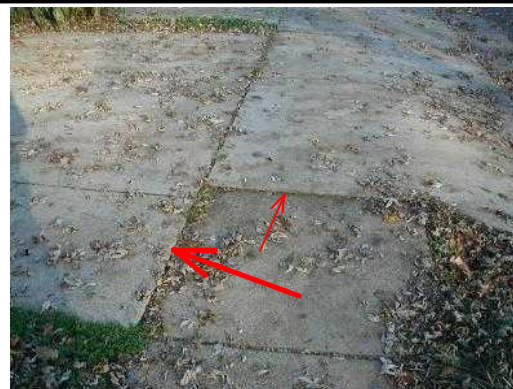
1. **Walks:** Concrete sidewalks. Trip hazards noted at several locations on front sidewalk

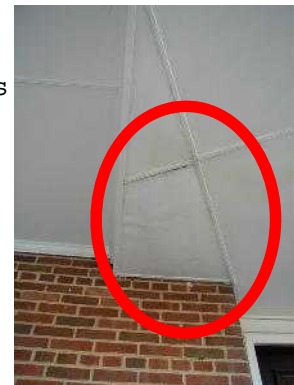
2. **Front porch** Concrete slab on grade on right front of house. Some water damage was observed on the ceiling - this MAY be from the bathroom exhaust fan, but I was unable to confirm because there was no access to the space above this ceiling.

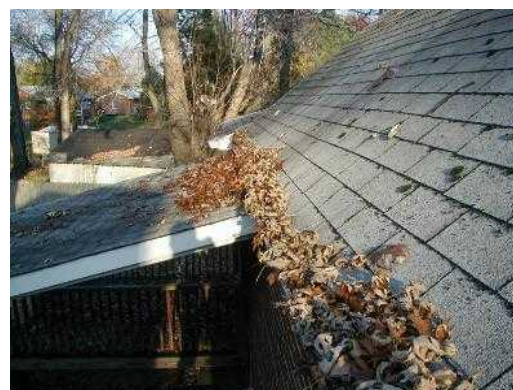
4. **Main Roof Surface Unable to Inspect:** 25%
5. **Gutters:** Aluminum. Although there are gutter guards present, the gutters still need cleaning.

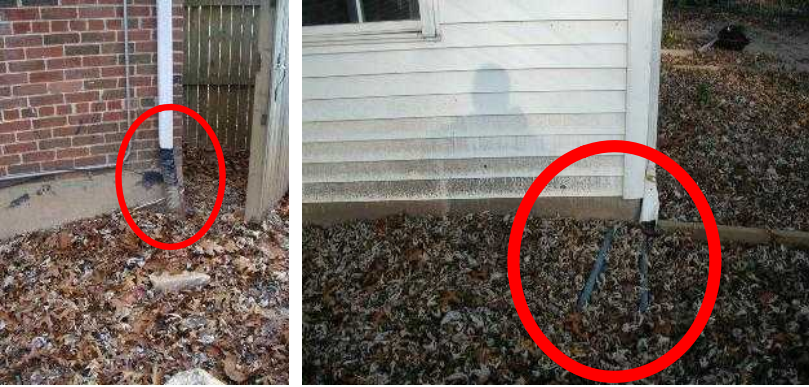
6. **Leader/Extension:** Some downspouts terminated into ground. Unable to determine where rain water discharges. Splash block(s) not properly installed. Leaders do not extend 6 feet beyond the foundation perimeter.

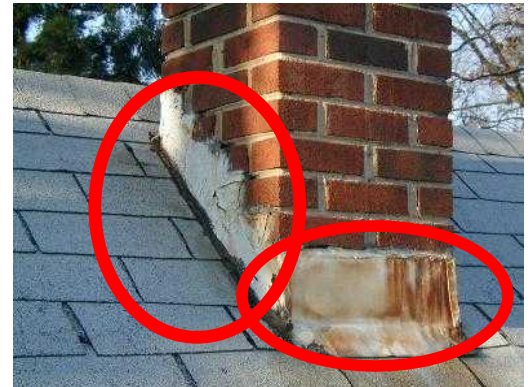
7. Center Chimney Flue/Flue Cap: There is no cap on the flue
8. Center Chimney Chimney Flashing: Metal. Loose counter flashing needs to be repaired.

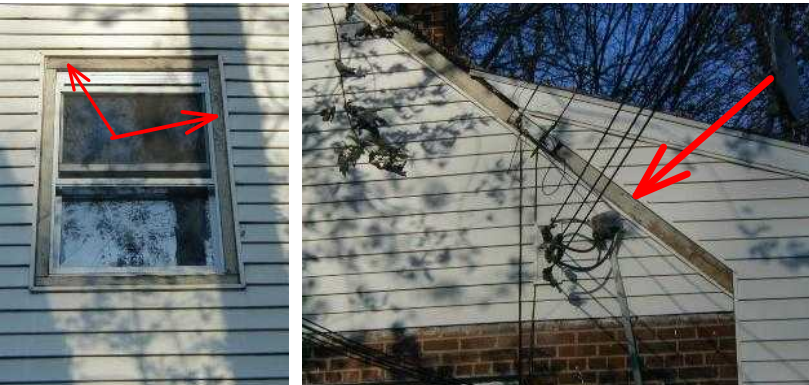
9. Trim: Some exposed wood trim and some trim wrapped with aluminum. Some exposed wood trim is in need of painting or replacement.

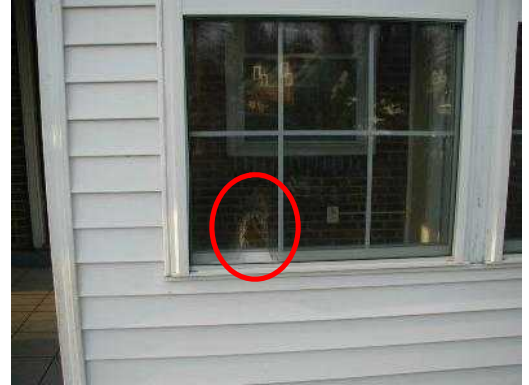
11. **Window Screens:** Vinyl mesh. Some screens were torn and will need repair

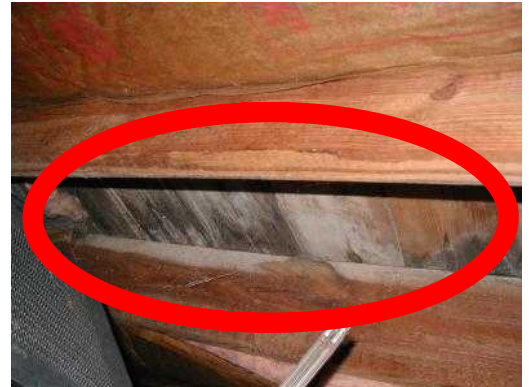
14. **Main Attic Unable to Inspect:** 90%
15. **Main Attic Sheathing:** Dimensional wood The limited areas where the batt insulation between the roof rafters was missing showed signs of water damage.

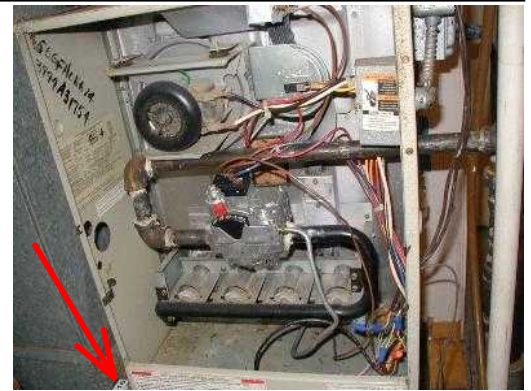
27. Basement Heating System Blower Fan/Filter: Filter was filthy and the filter section cover was not in place. The absence of the filter section cover will allow dirty air to by-pass the filter.

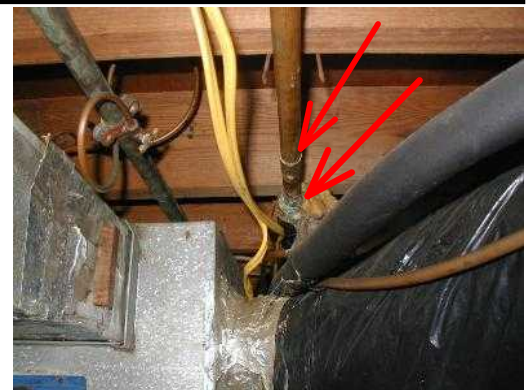
29. Water Lines: Copper. Signs of corrosion and several inline couplings were present. These may be signs of past plumbing leaks. Recommend that all piping be inspected by a licensed plumber. Access to view the pipes was limited by the existing drop ceiling and drywall ceiling in the basement.

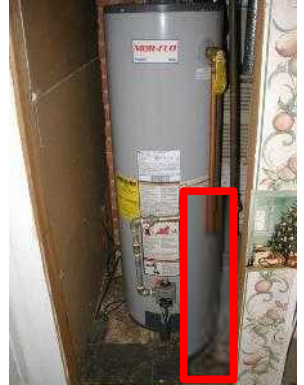
31. **Basement Water Heater TPRV and Drain Tube:** Copper Drain pipe from TPR valve is greater than 24" off floor. It is recommended that the discharge point be 6" to 24" from the floor.

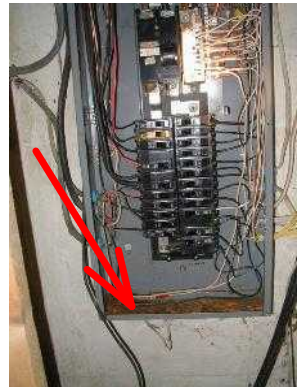
34. **Basement on west side of house Electric Panel Manufacturer:** Square D. Evaluation by a licensed electrician is recommended, Panel is rusted inside, Wiring appears to be less than professional

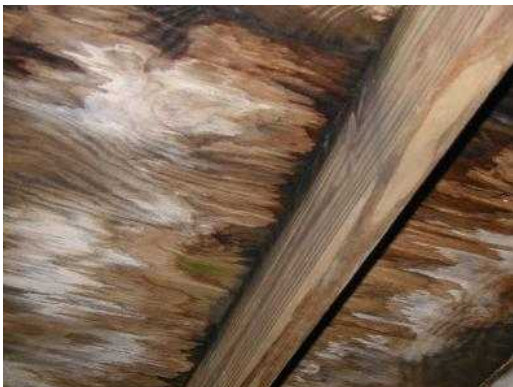
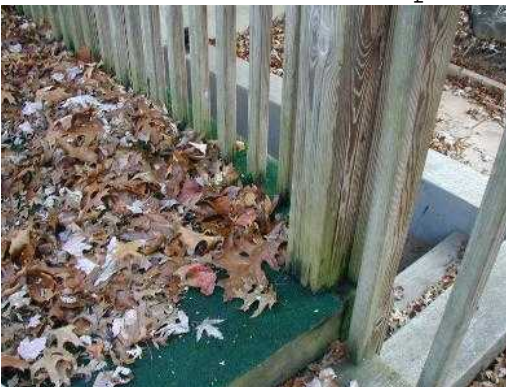
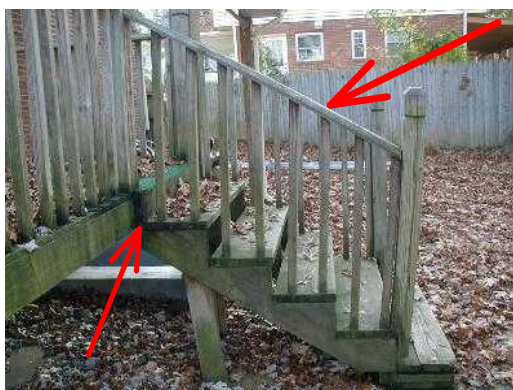
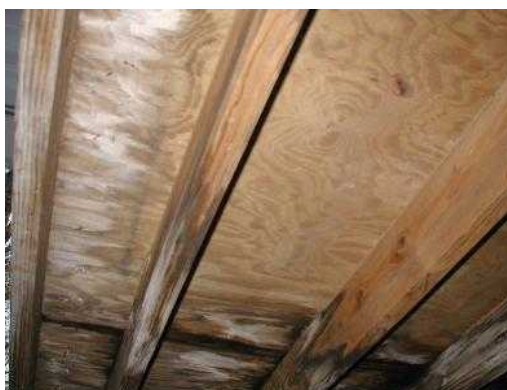
1. **Deck:** Plywood over wood joist The handrail are very loose. The carpet over the plywood decking holds water and promotes rotting of structure. Plywood should not be used on an exterior deck. The construction indicates poor workmanship.

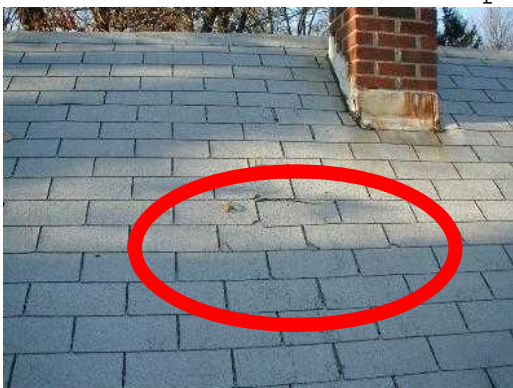
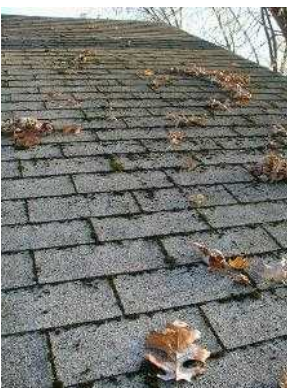
3. **Main Roof Surface Material:** Asphalt shingle. Loose or damaged shingles were observed. Moss was present on north side of the roof. A qualified roofing contractor is recommended to evaluate and estimate repairs.

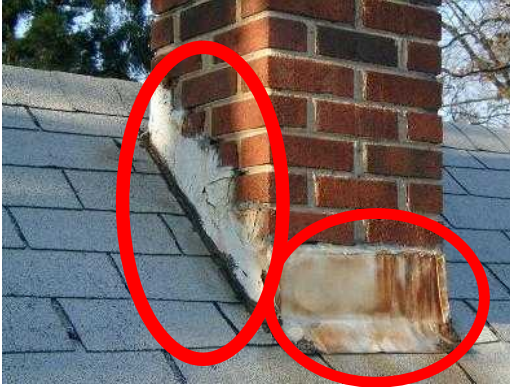
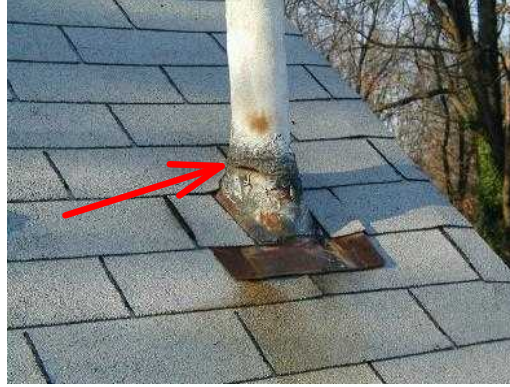
4. **Flashing: Galvanized.** The flashing at the chimney should be recessed into the mortar joint. The flashing around the plumbing vents is defective and needs to be repaired

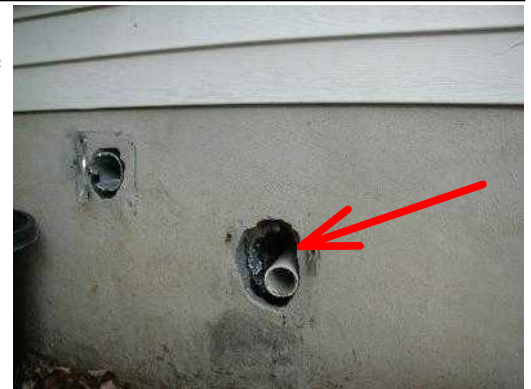
6. **Under new addition Crawl Space Ductwork:** There is evidence that the dryer exhaust, which is flex duct, runs through the crawlspace. Although I could not observe the duct in the crawlspace because of limited access, I do not believe it can be properly cleaned of lint. This is a fire hazard.

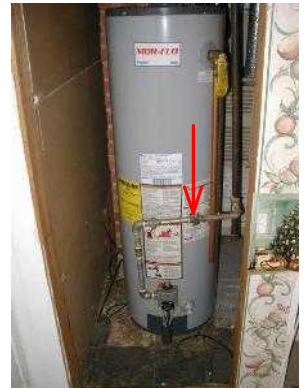
21. Gas Service Lines: Black metal pipe. Shut off valve on gas line is broken.

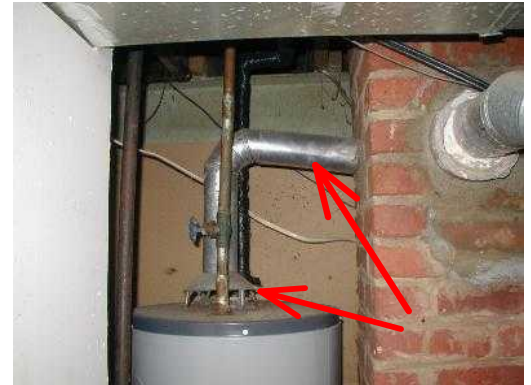
22. Basement Water Heater Flue Pipe: Single wall Negative slope

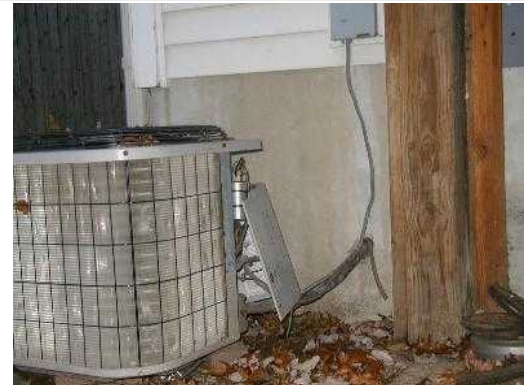
23. Main AC System A/C System Operation: Unable to get the unit to operate, Unit appears to be beyond its useful life. Recommend replacement.

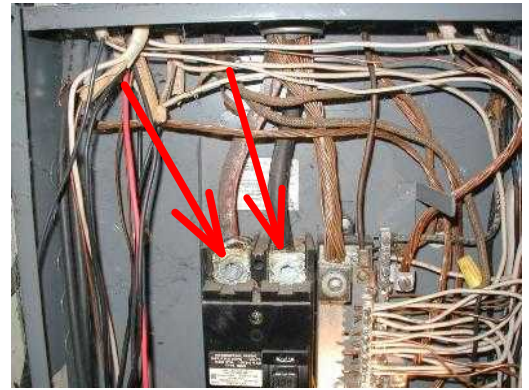
25. **Service Copper.** Evaluation by a licensed electrician is recommended, 14 gauge wires going into a 20 amp breaker (20 amp circuits require 12 gauge wiring). Corrosion evident on incoming feed taps. Rust in the bottom of the panel.
